PIC32MZ Graphics (DA) Family

PIC32MZ Graphics (DA) Family Silicon Errata and Data Sheet Clarification

The PIC32MZ Graphics (DA) family devices that you have received conform functionally to the current Device Data Sheet (DS60001361D), except for the anomalies described in this document.

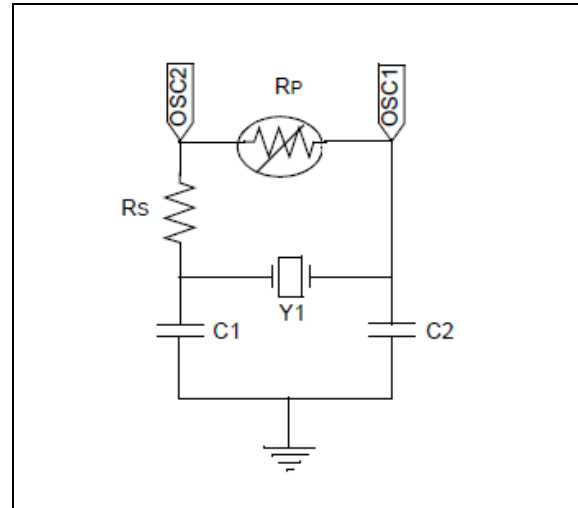
FIGURE 1: Posc CRYSTAL CIRCUIT

The POSC has been tested in a normal power-up sequence and supports specific crystal operation.

The Primary Oscillator (POsc) has been characterized to operate at 8 MHz and 12 MHz when the circuit shown in Figure 1 is implemented, and the operating conditions listed in Table 3 are met.

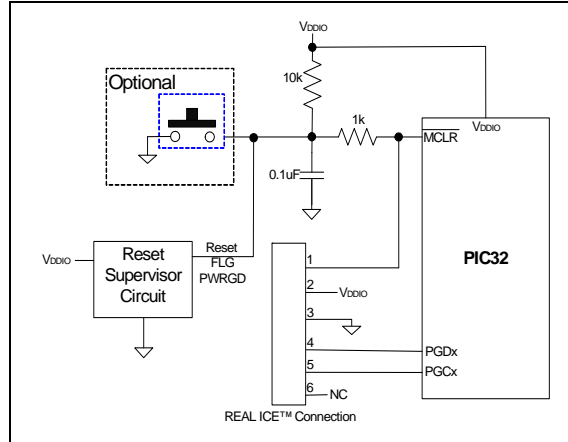
FIGURE 2: EXTERNAL RESET CIRCUIT

A system Reset is not generated on a BOR event ($V_{PORIO} < V_{DDIO} < V_{BORIO}$). This will stop system clocks with all the I/O pin functions frozen in the present state until either V_{DDIO} falls to V_{PORIO} or $V_{DDIO} > V_{BORIO}$.

Reset device using a \overline{MCLR} pin through an external reset supervisor/monitor is shown in Figure 2. Set the SMCLR (DEVCFG2<15>) configuration bit to '0', which makes the \overline{MCLR} to act as a POR Reset instead of a normal system reset.

- Minimum Reset trip voltage of the external supervisor should be $V_{BORIO} (Max) + 0.5V$.
- The external reset supervisor/LDO output going to \overline{MCLR} should have an open drain output to not interfere with the MPLAB programming/debug tools.

When this work around is implemented, the minimum V_{DDIO} operating voltage of the application needs to be above the reset supervisor

maximum trip voltage + 0.2V, where 0.2V compensates for variation in the external reset supervisor voltage.
